Journal Article

Glacier Lake 513, Peru: Lessons for early warning service development

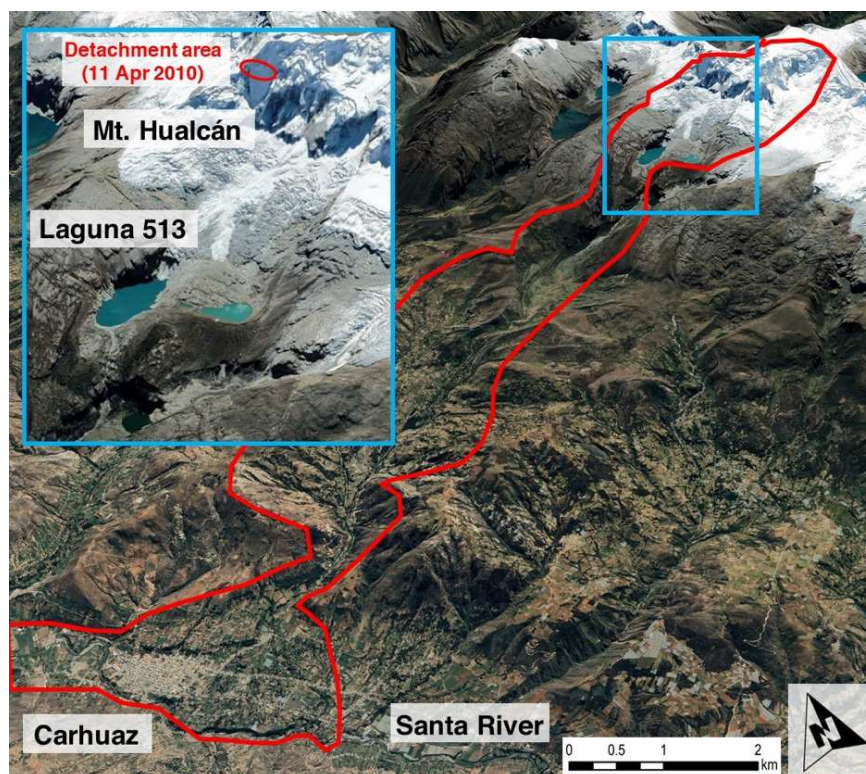
Overview map of Lake 513 and Carhuaz, indicating the 2010 ice avalanche source zone producing the GLOF that reached down to Carhuaz.

However, Laguna 513 was heavily impacted when a 450 000 cubic metres (m³) rock-ice avalanche detached from the southwest slope of Mt. Hualcán (Carey et al., 2012) (Fig. 2) on 11 April 2010, at about 8 a.m. local time. The avalanche caused a tsunami-like push-wave on the lake, resulting in a dam spillover despite the over 20 m freeboard. Traces of the wave indicate an overtopping of the dam by about 5 m – corresponding to a wave height of about 24 to 25 m – with a peak discharge of rate of several tens of thousands m³ per second (Schneider et al., 2014). The resulting GLOF damaged several bridges, water service infrastructure along its trajectory and eventually reached the debris fan of the city of Carhuaz (about 20 000 inhabitants), where the coarse material of the GLOF was deposited. A total of 0.7 km² of agricultural land was buried and the Santa Valley highway was affected, but no lives were lost.

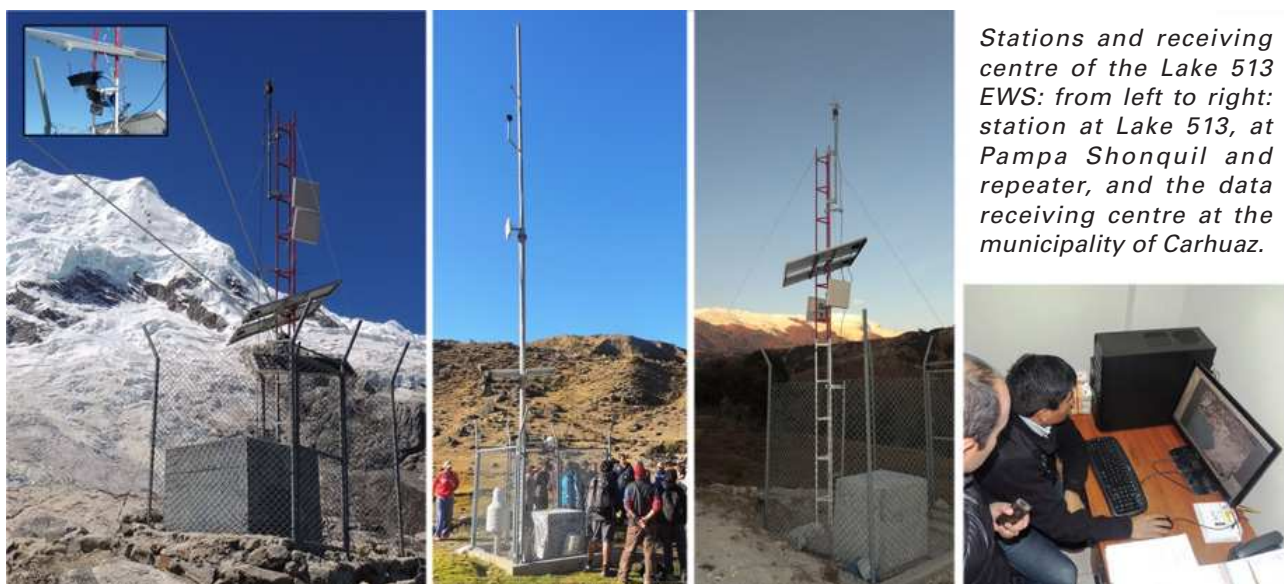
Stations and receiving centre of the Lake 513 EWS: from left to right: station at Lake 513, at Pampa Shonquil and repeater, and the data receiving centre at the municipality of Carhuaz.

With the knowledge and information gathered, the local and international team worked together, each contributing their expertise, to design an EWS that would overcome the challenges of Laguna 513. The design comprised two stations – a main station at the Laguna 513 dam and a station in the Pampa Shonquil,

which would include meteorological measuring instruments – a data centre in the municipality of Carhuaz, a warning station in the community of Pariacaca, and a repeater station for transferring the signal from the lake to the data centre (Fig. 3).

1. Data centre Carhuaz (2 640 m a.s.l.): receiving antenna, screen with real-time data access, server for data storage, infrastructure for launching alarms.
2. Repeater station (3 189 m a.s.l.): receiving and sending antenna.
3. Station Laguna 513 (4 491 m a.s.l.): 2 cameras taking photos every 5 seconds during daylight times, one looking at the face of Mt. Hualcán, one observing the dam. 4 geophones located close to the station, continuously measuring and sending data in 5 second intervals, in order to detect potential mass movements (e.g. ice avalanche) impacting the lake. Receiving and sending antenna and data logger.
4. Station Pampa Shonquil (3 600 m a.s.l.): river discharge station (using pressure sensor), meteorological station with sensors for measuring

All stations were equipped with solar panels and batteries for energy generation and storage, however energy availability remained a limiting factor, in particular at the glacier lake station as the peaks of the Cordillera Blanca experience a high frequency of cloud coverage. Each station had a mast where most of the instruments were fixed, a concrete lockable box for the electronic equipment, and a protective fence. Emergency power aggregates were available in the municipal building to prevent data losses and interrupted access during blackouts.
